Jordan River Corridor Preservation Study

Prepared for
City of Saratoga Springs

Prepared by
**JE Fuller/Hydrology &
Geomorphology, Inc.**

March 2007

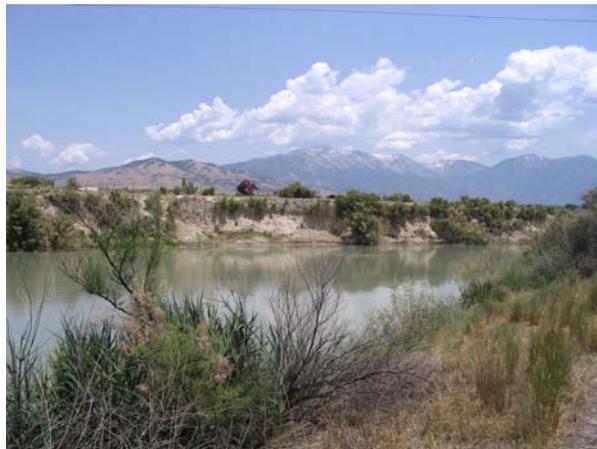
FIGURE 3-9
Tall Vertical Cutbank on Outside of Bend Downstream of Willow Park

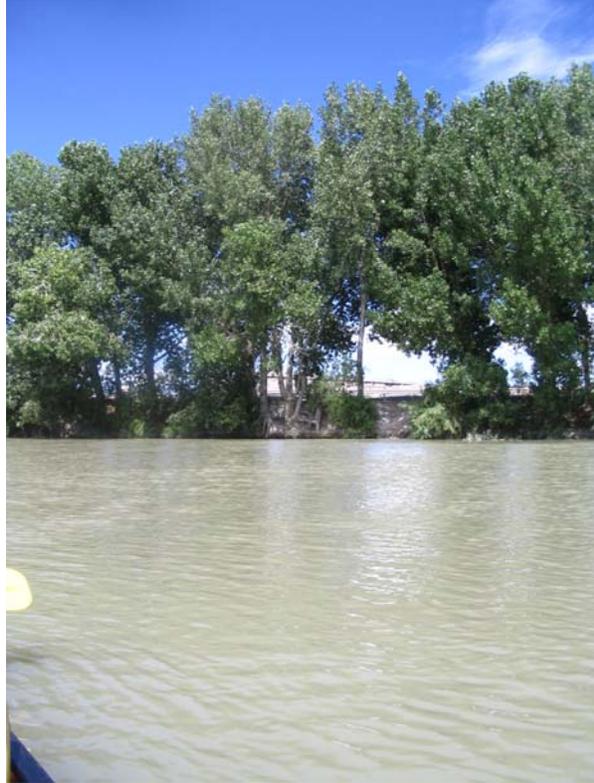
FIGURE 3-11
Erosive Cutbanks Exposing Roots of Woody Bank Vegetation

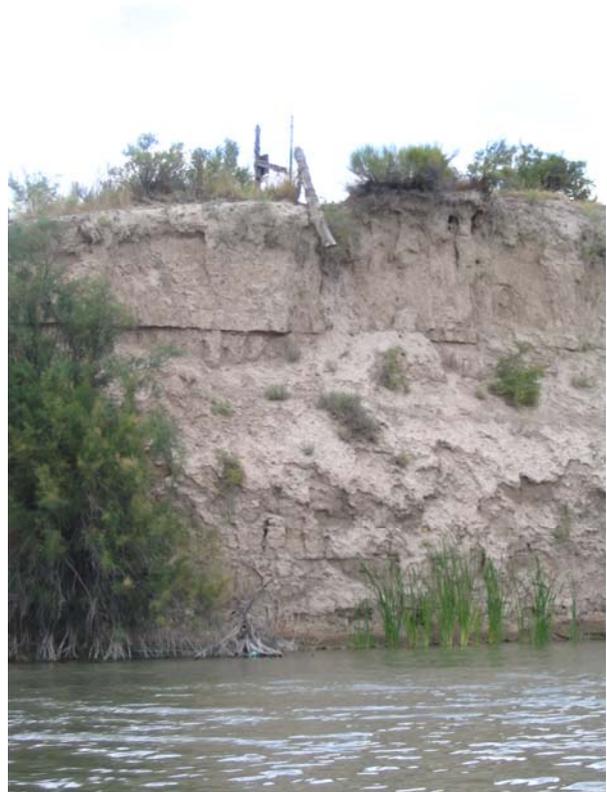
FIGURE 3-12
Tall Cutbank with Hanging Fence Post Indicative of Recent Bank Failure

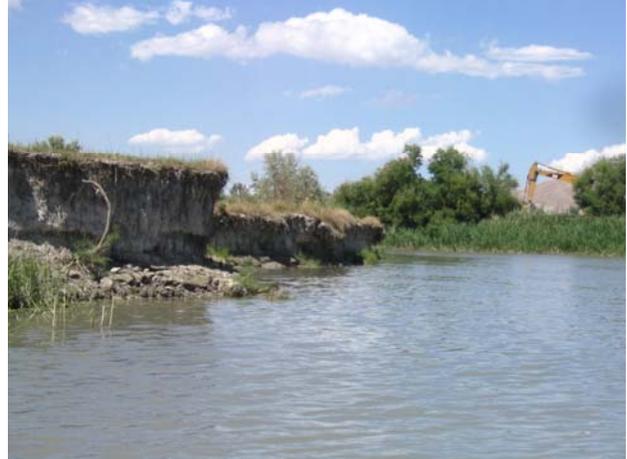
FIGURE 3-14
Undercutbank with Accelerated Erosion at Toe of Vertical Bank Slope

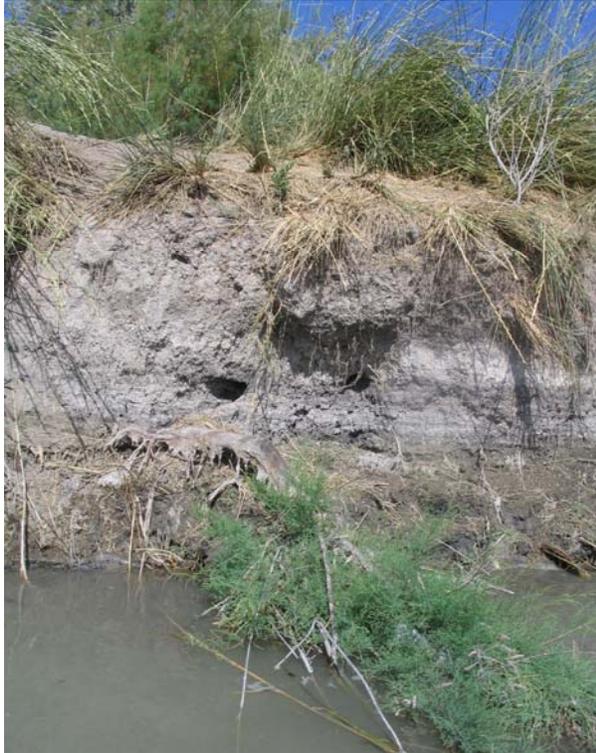
Bank Soil Profiles. Channel banks in the study are composed of sandy clay loam soils. Little variability in bank sediment composition was observed within the study reach. The bank soils have enough silt/clay content to stand at vertical slopes, develop a blocky soil texture, and

retain soil moisture, but do not have enough clay content to be resistant to lateral erosion from loss of basal support. The bank materials contain very little sediment coarser than medium sands although some lenses with gravel were observed in a few places.

FIGURE 3-15
Cutbank Showing Bank Soil Characteristics Such as Fine Stratification, Preferred Rooting Zones, Piping, and Fine-Grained Texture

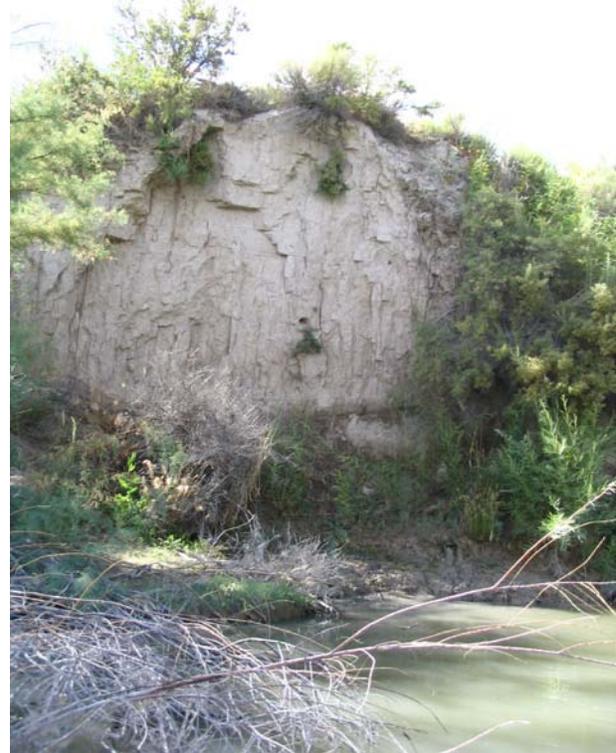
FIGURE 3-16
Tall Cutbank Illustrating Capacity of Bank Soils to Maintain Vertical Slopes and Common Blocky Soil Texture Due to Fine-Grained Content

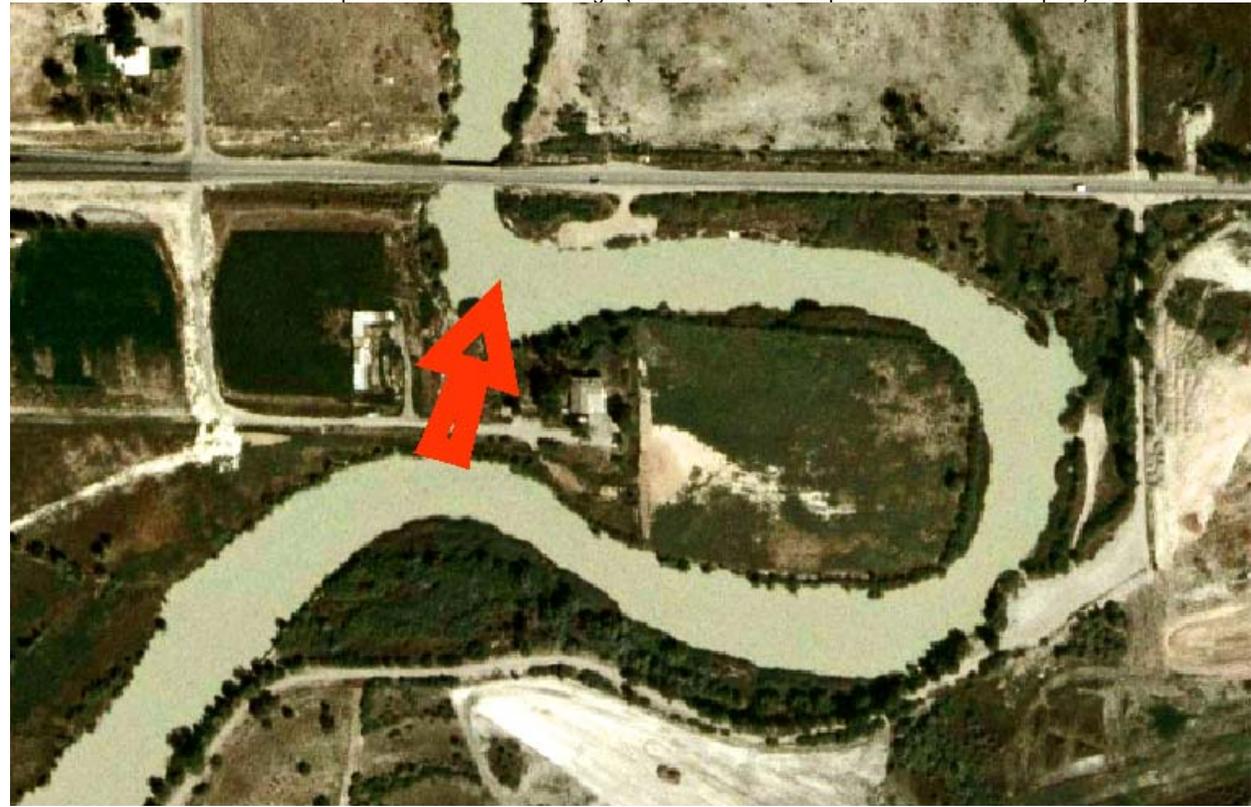
FIGURE 3-24

Potential Future Meander Cutoff Upstream of The SR73 Bridge (Red arrow indicates possible future cut off path)

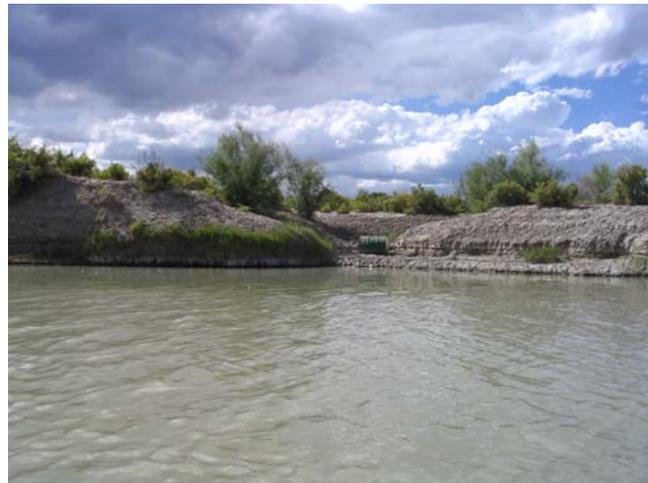
FIGURE 3-38
Overgrazed Area Devoid of Vegetation with Barrel of Unknown Source and Substance at Waterline

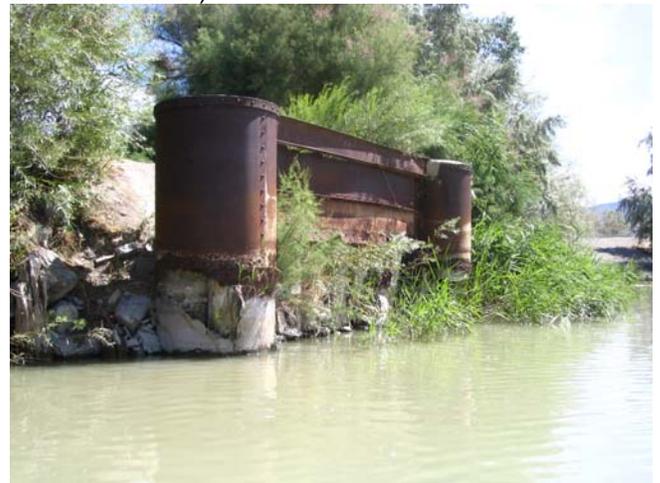
FIGURE 3-39
Corroding Abandoned Bridge Abutment (Note damage to concrete and metal elements)

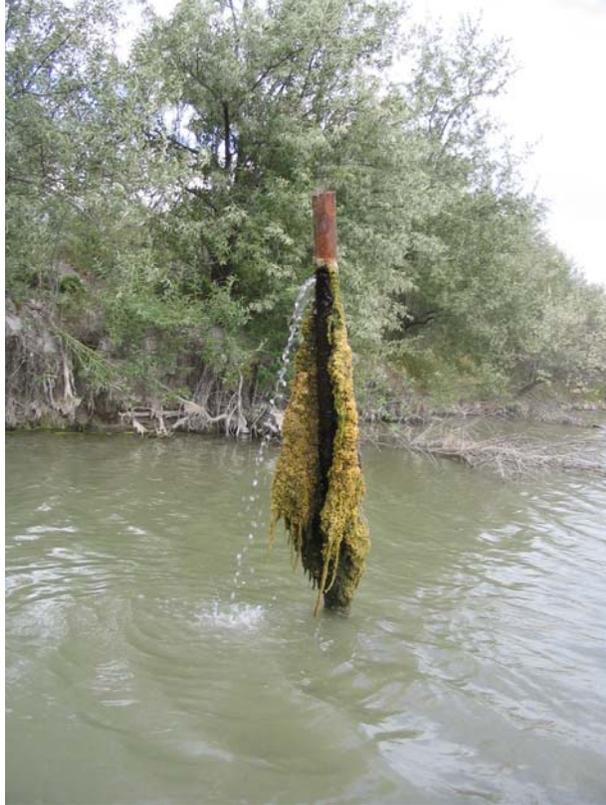
FIGURE 3-40
Water Flowing From Pipe with Apparent Calcium Carbonate Build Up

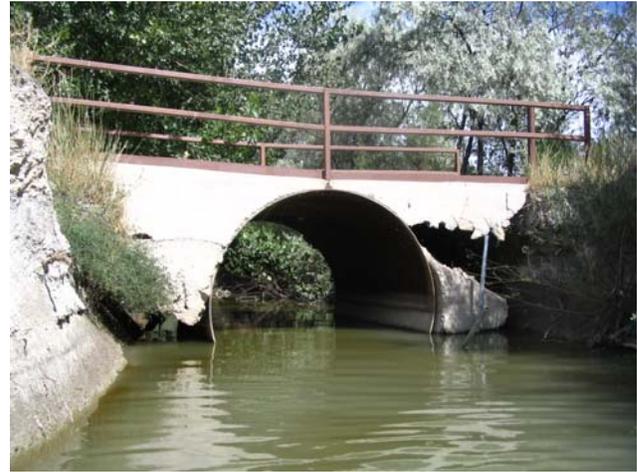
FIGURE 3-43
Failure of Tributary Culvert Crossing Due to Apparent Loss of Foundation

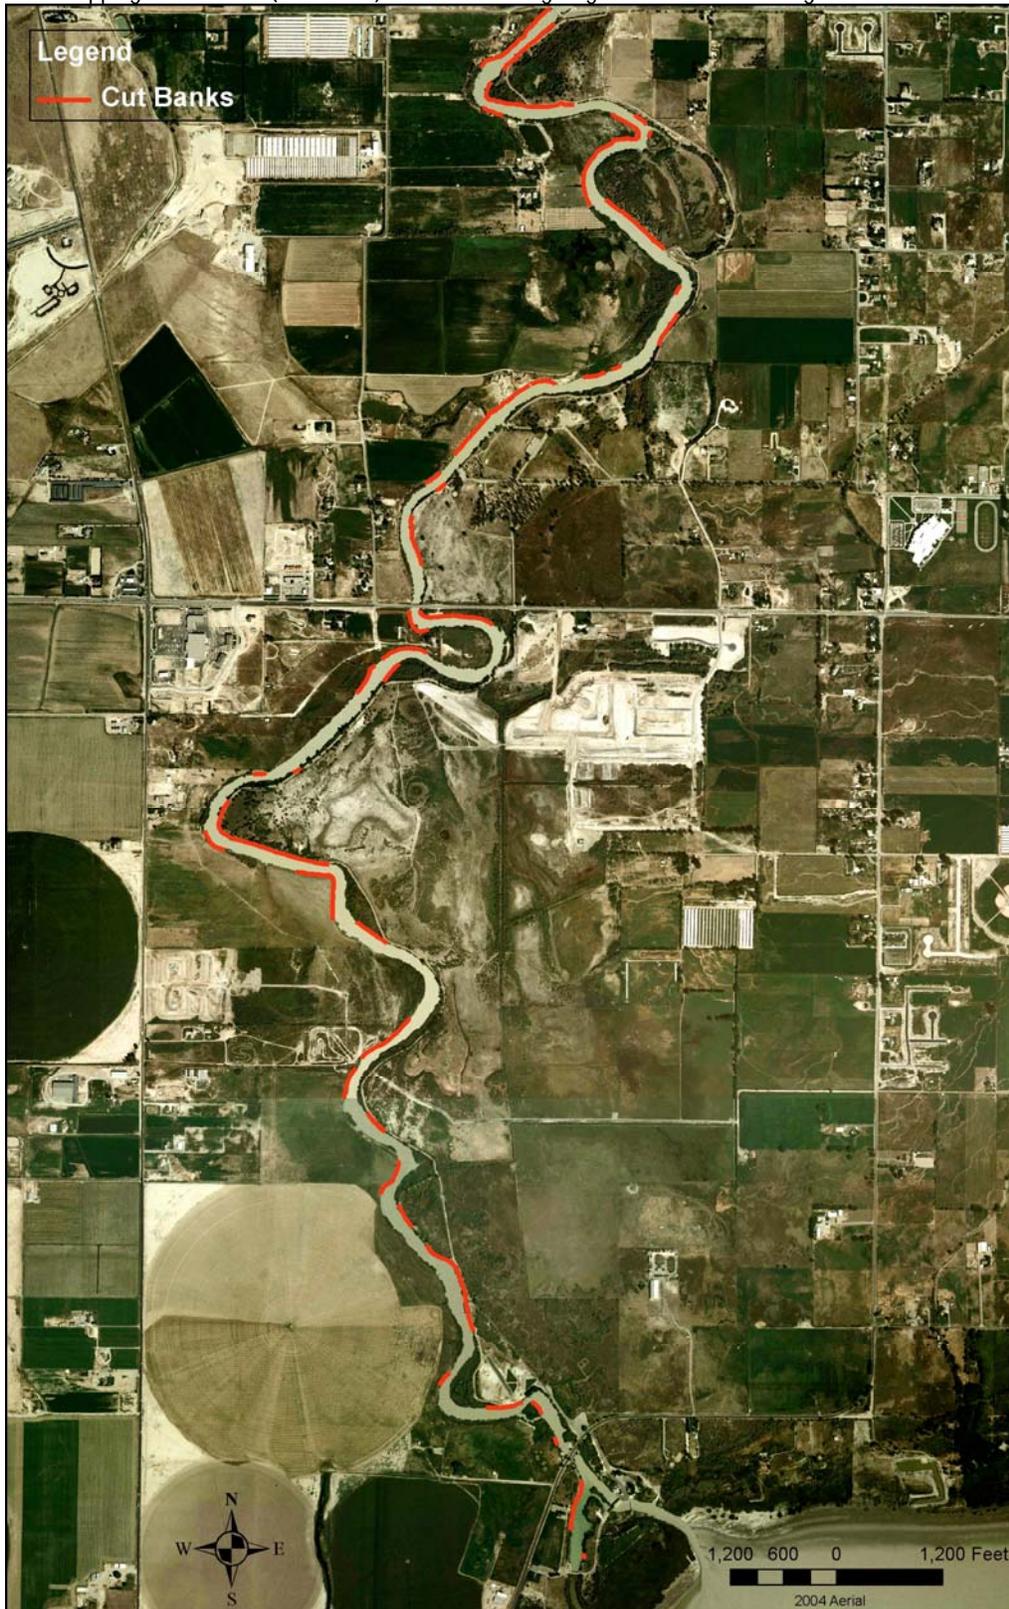
FIGURE 3-45
Field Mapping of Cutbanks (Red Lines) Observed During August 2006 Field Investigations

The field assessment of bank stability indicated the presence of numerous (up to 37 percent) unstable cutbanks, many of which probably formed since the river was dredged in the 1980's. The extent and location of the cutbanks cannot be fully explained by normal, equilibrium stream process, pointing to a disequilibrium condition to which the study reach is adjusting.

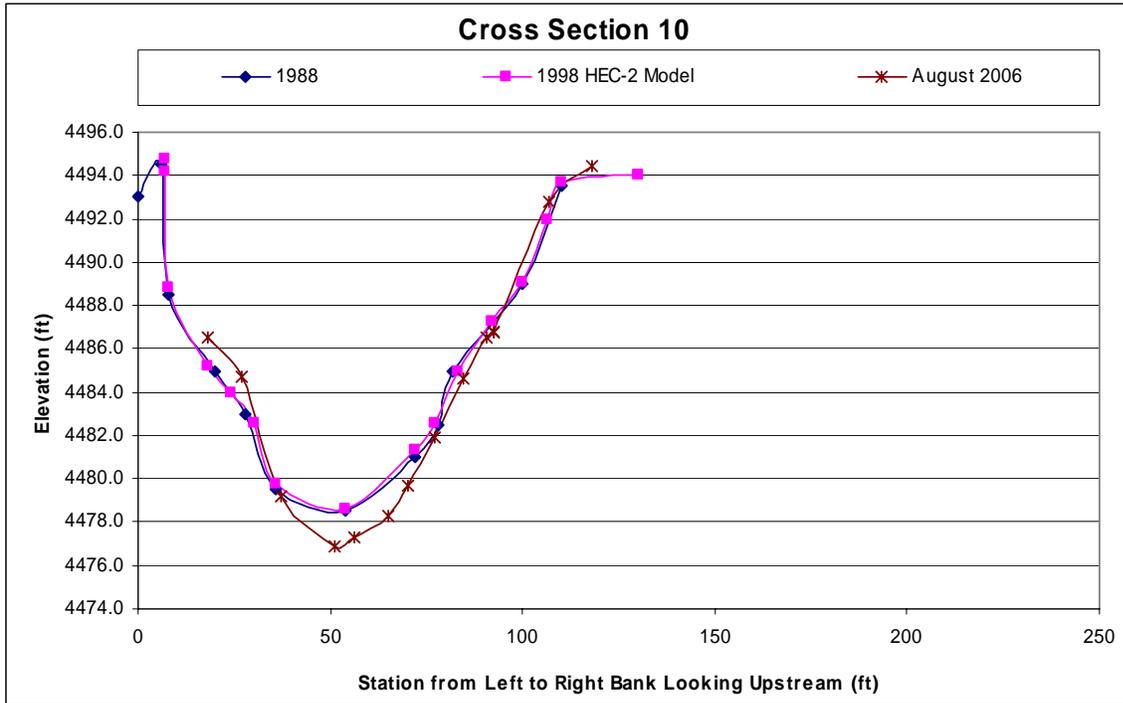
FIGURE 5-3
 Cross Section #10 Profiles, 1988-2006, Downstream of Saratoga Springs Road Net degradation

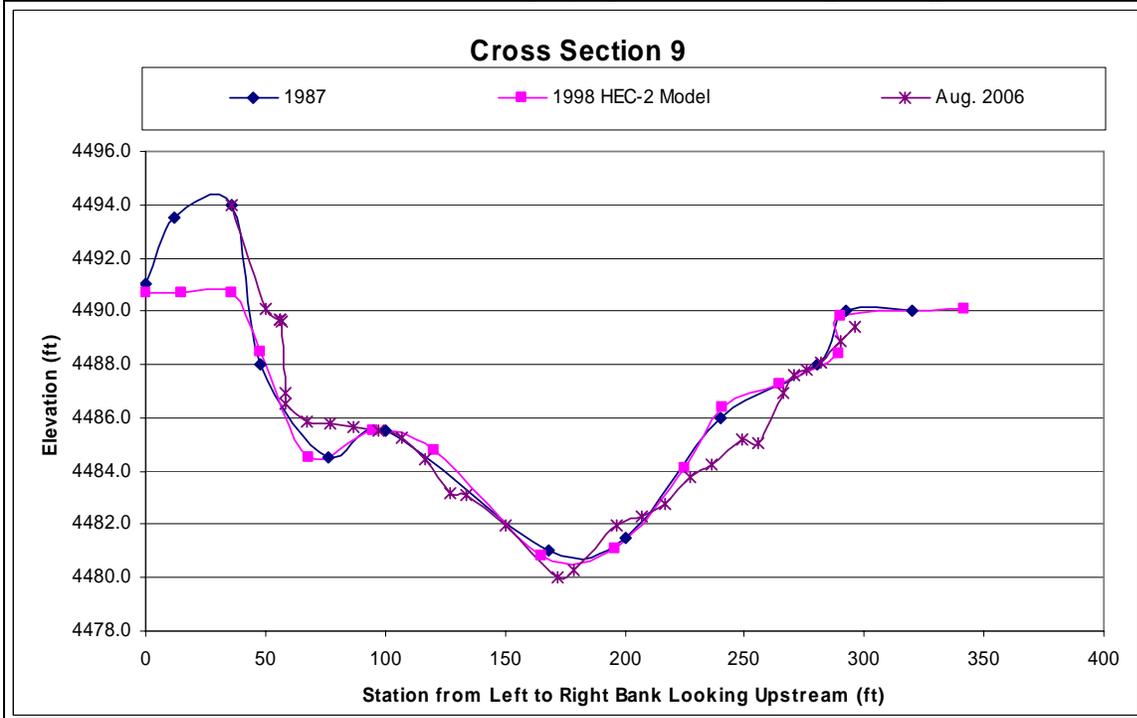
FIGURE 5-4
 Cross Section #9 Profiles, 1988-2006 Between Saratoga Springs Road and SR 73 Slight Net Degradation and Widening

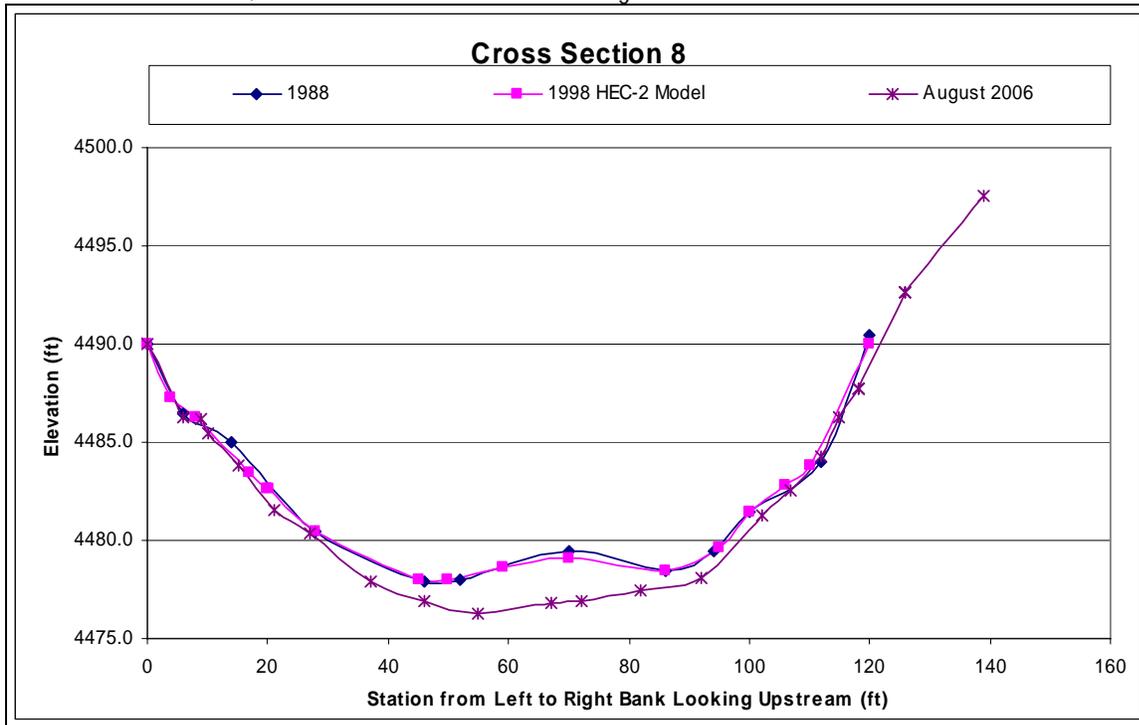
FIGURE 5-5
 Cross Section #8 Profiles, 1988-2006 Downstream of SR 73 Degradation

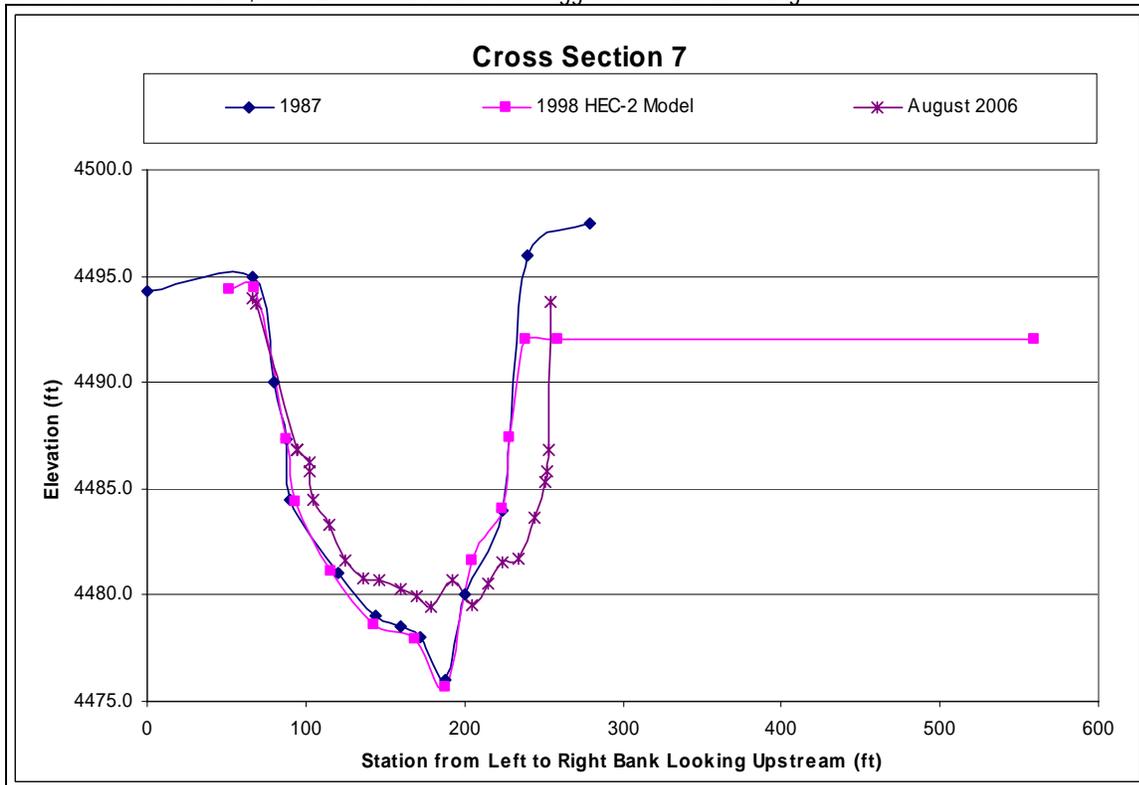
FIGURE 5-6
 Cross Section #7 Profiles, 1988-2006 Near Willow Park Aggradation and Widening

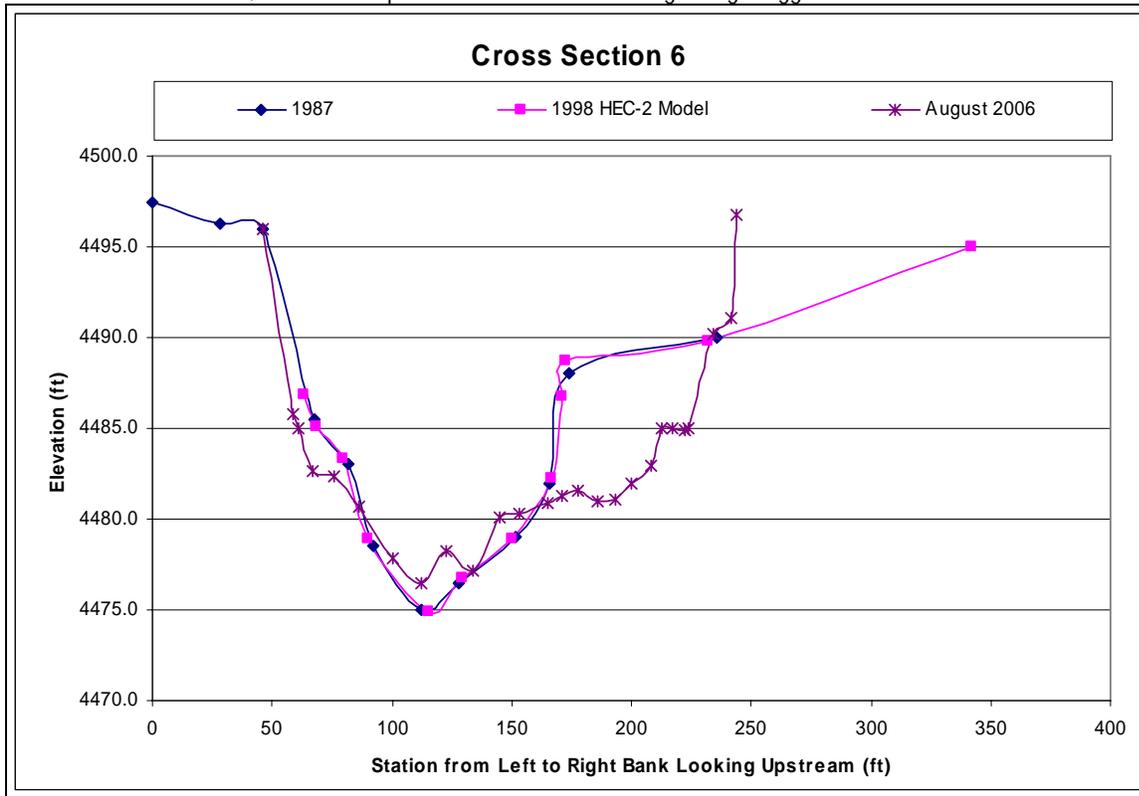
FIGURE 5-7
 Cross Section #6 Profiles, 1988-2006 Upstream 9600 North Widening & Slight Aggradation

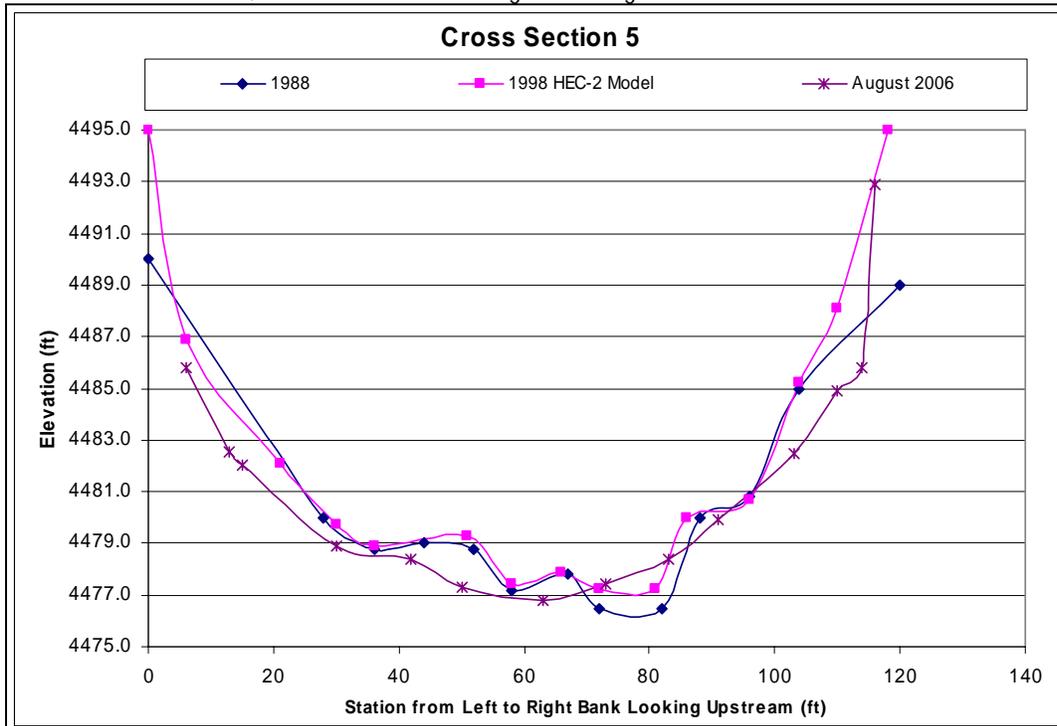
FIGURE 5-8
 Cross Section #5 Profiles, 1988-2006 9600 North Slight Widening
