Jordan River Corridor Preservation Study

Prepared for
City of Saratoga Springs

Prepared by
**JE Fuller/Hydrology &
Geomorphology, Inc.**

March 2007

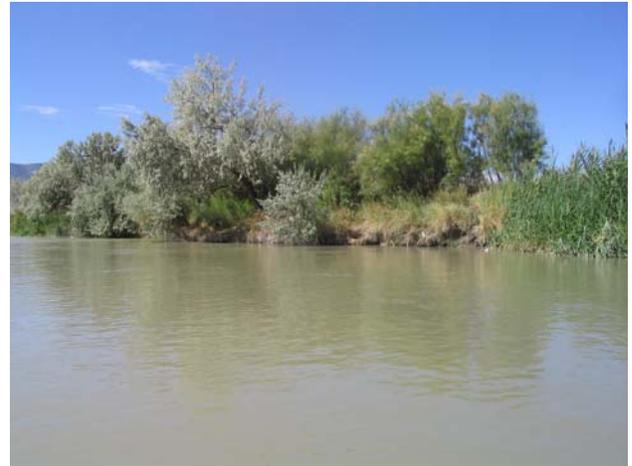
FIGURE 3-6
 Mixed Brushy and Woody Vegetation with Toe Scour at the Waterline

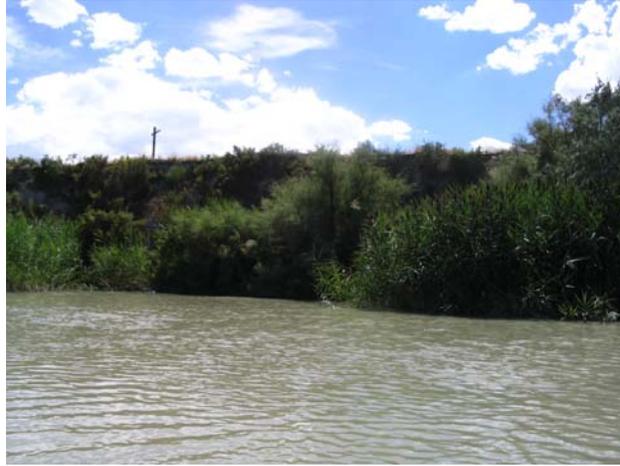
FIGURE 3-7
New Bank Vegetation Colonizing Toe of Recently Eroded Cutbank

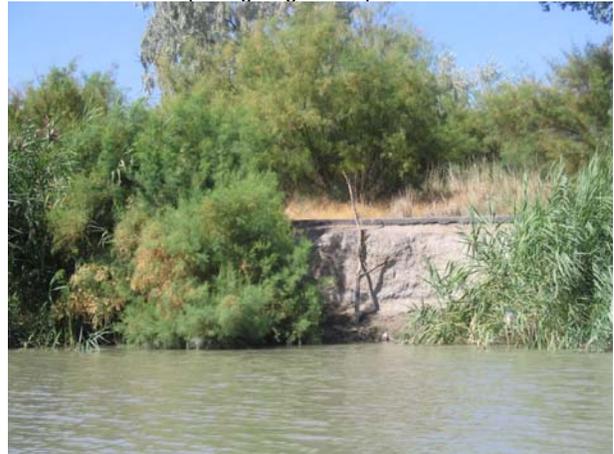
FIGURE 3-10
Recent Erosion Exposing Edge of Asphalt Bike Path Surface

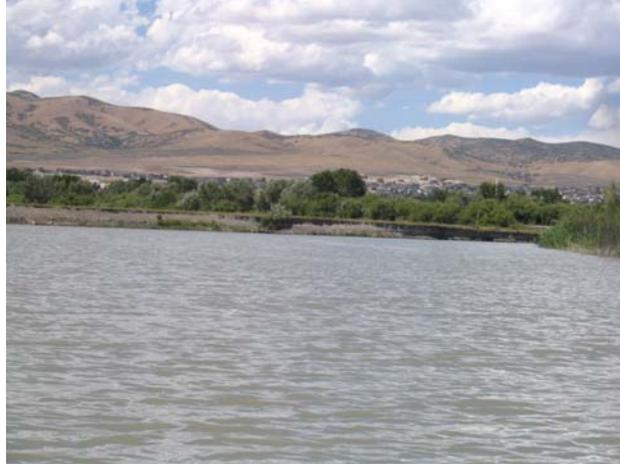
Cutbanks. Vertical or near-vertical cutbanks were observed throughout the study reach, as documented later in this chapter. In many locations, cutbanks were observed on both banks, rather than just on the outside of channel bends as would occur on most meandering rivers. The double cutbanks indicate a disequilibrium condition or river response to an artificially imposed channel or hydrologic condition.

FIGURE 3-13
Long Low Cutbank Adjacent to Low Floodplain Surface

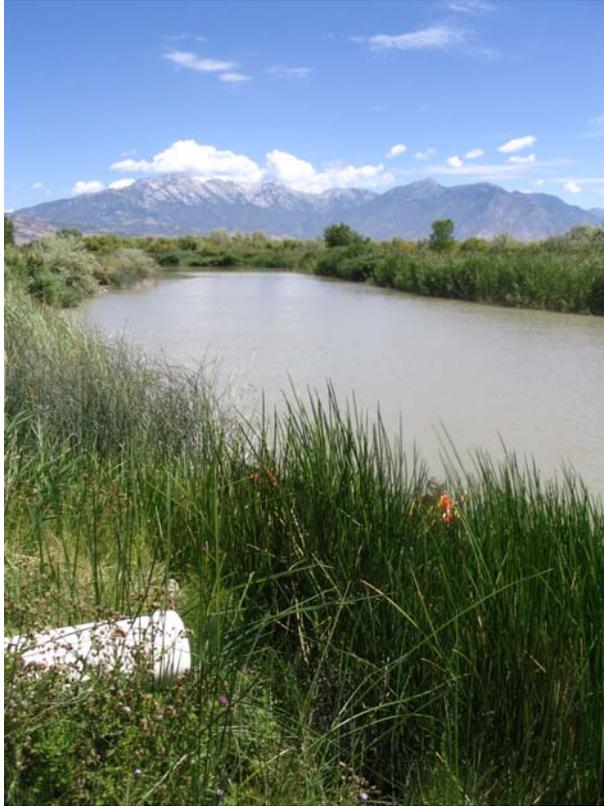
FIGURE 3-26

Storm Drain Inlet Perched Above Active Channel With Minimal Scour

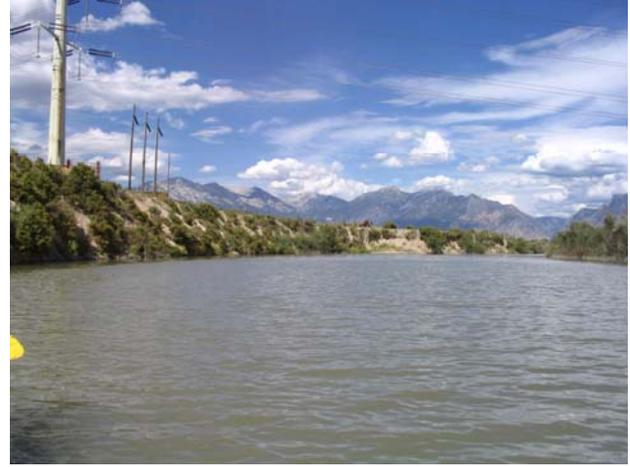
FIGURE 3-31
High Tension Power Lines and Power Pole Adjacent to Eroding Cutbanks

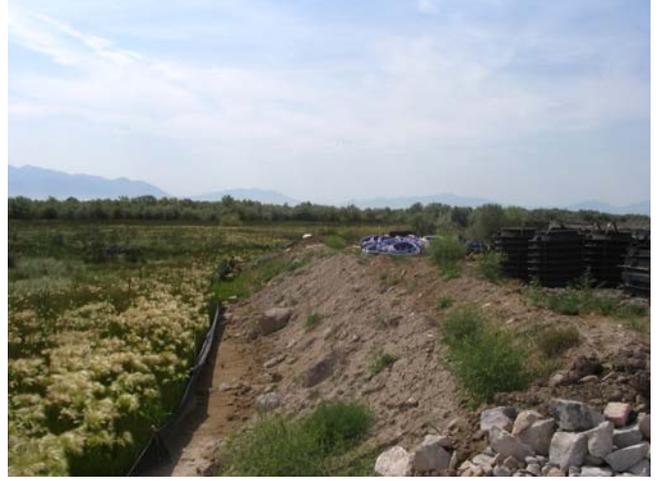
FIGURE 3-33
Fill Placed in the Floodplain for Expansion of Developed Areas

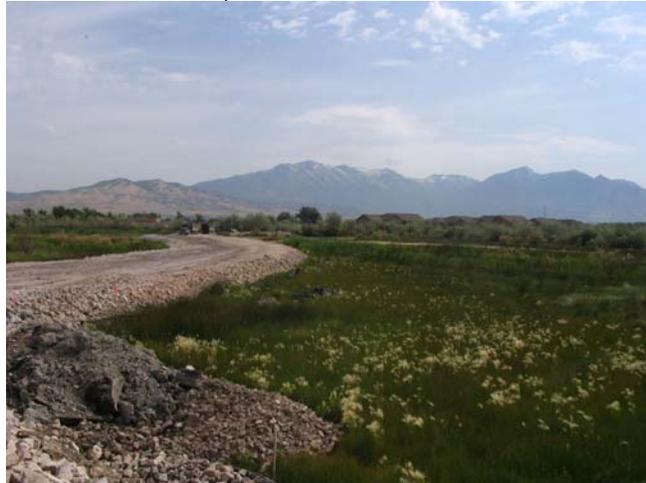
FIGURE 3-34
Fill Placed Across Wetlands and Floodplain Storage Areas for Access to New Development

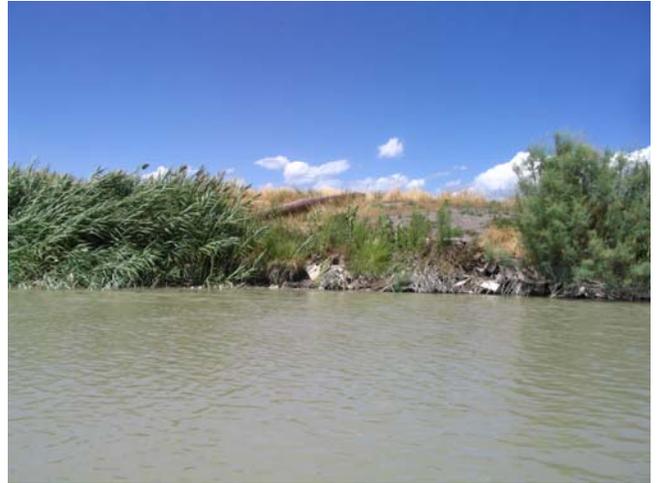
FIGURE 3-35
Trash Dumped Over the Bank of the Main Channel in the Study Reach

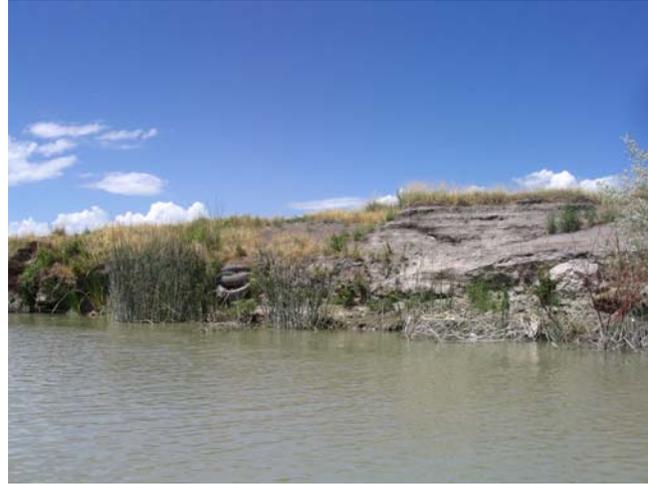
FIGURE 3-36
Tires and Dumped Material Integrated Into the Main Channel Bank Profile

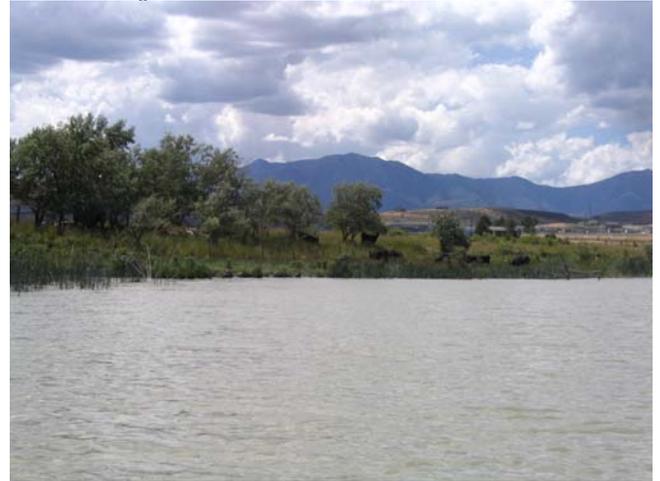
FIGURE 3-37
Cattle Grazing on the Main Channel Bank Line

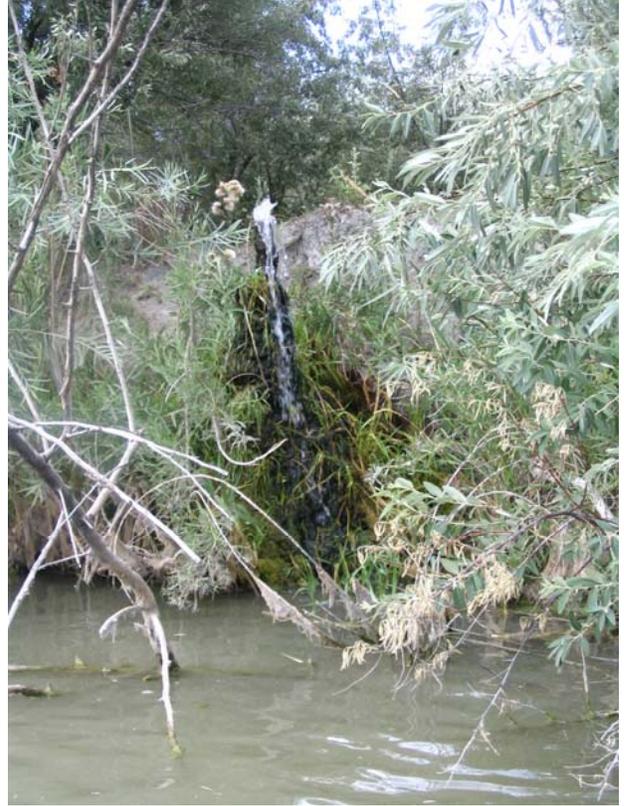
Other River Features. Several other noteworthy features observed in the study reach include pipes with extensive calcic build-up discharging what appeared to be spring flow into the river and several wooden structures of unknown purpose. These features do not appear to impact river morphology or lateral erosion potential.

FIGURE 3-41
Pipe Discharging Spring Water to Main Channel of Jordan River

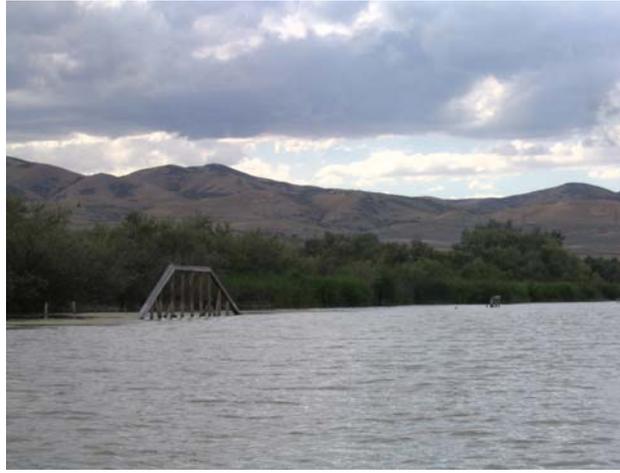
FIGURE 3-43
Failure of Tributary Culvert Crossing Due to Apparent Loss of Foundation

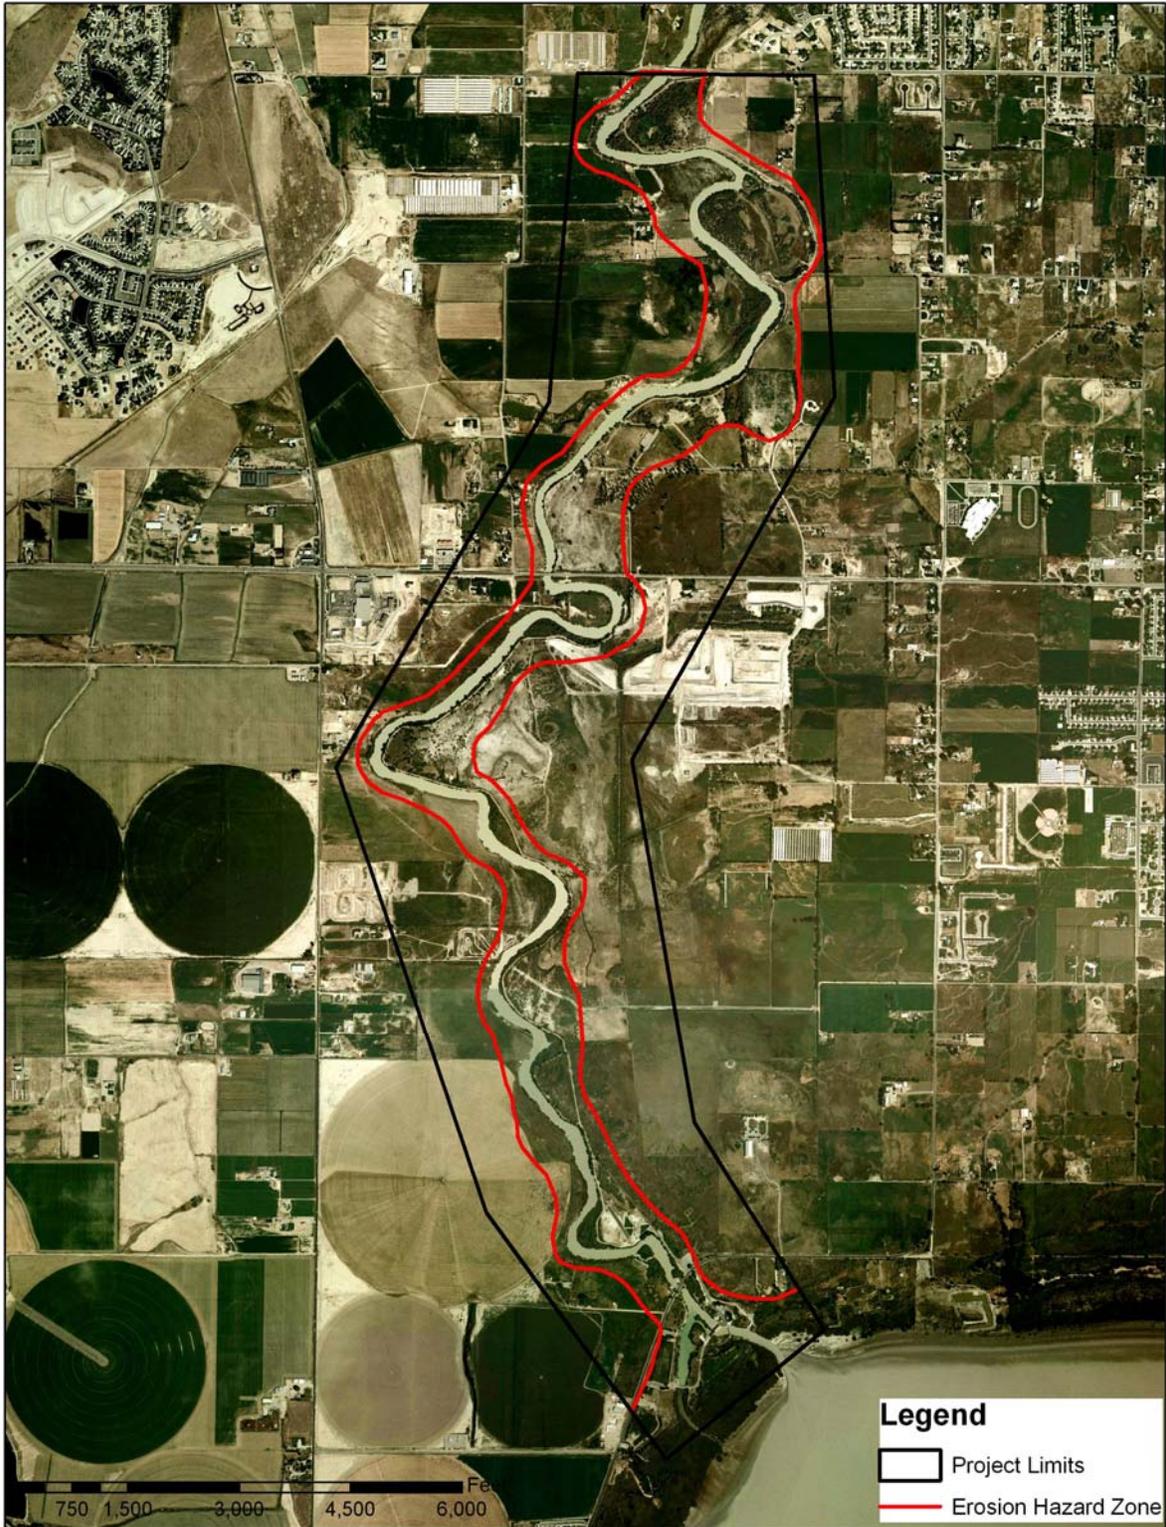
The recommended Jordan River erosion hazard zone, based on the information summarized previously, is shown in Figure 7-4. The erosion hazard zone represents the areas with some risk

The erosion hazard zones reflects the data available at the time of the study, the accuracy of the FIS hydraulic modeling, as well as the historical record of channel change in the study reach. If reach conditions change significantly in the future due to floods, drought, land use, or human activities in or along the river, revision of the erosion hazard zone delineation may be warranted.

FIGURE 7-4
Recommended Erosion Hazard Zone for the Jordan River Study Reach
